Mars Climate Orbiter

Mishap Investigation Board

Phase I Report

November 10, 1999

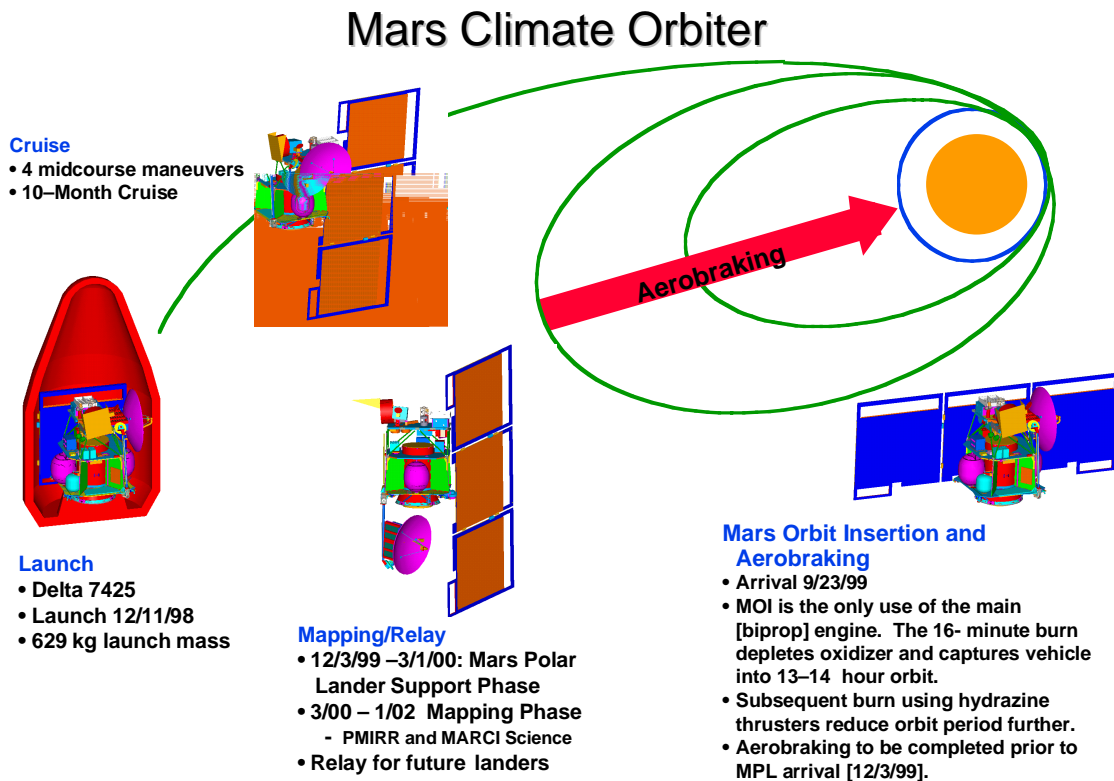
Figure 1

Nine and a half months after launch, in September 1999, MCO was to fire its main engine to achieve an elliptical orbit around Mars. See figure 1. The spacecraft was to then skim through Mars' upper atmosphere for several weeks in a technique called aerobraking to reduce velocity and move into a circular orbit. Friction against the spacecraft's single, 5.5-meter solar array was to have slowed the spacecraft as it dipped into the atmosphere each orbit, reducing its orbit period from more than 14 hours to 2 hours. On September 23, 1999 the MCO mission was lost when it entered the Martian atmosphere on a lower than expected trajectory.

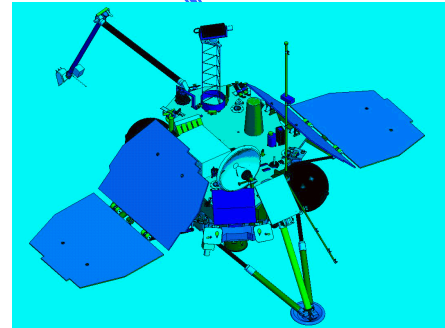
Figure 2

Landed Operations

- 76° S Latitude, 195° W Longitude
- Ls 256 (Southern Spring)
- 60–90 Day Landed Mission
- MVACS, LIDAR Science
- Data relay via Mars Climate Orbiter or MGS
- Commanding via Mars Climate Orbiter or direct-to-Earth high-gain antenna

Like Mars Pathfinder, MPL will dive directly into the Martian atmosphere, using an aeroshell and parachute scaled down from Pathfinder's design to slow its initial descent. See figures 2 and 3. The smaller MPL will not use airbags, but instead will rely on onboard guidance, radar, and retro-rockets to land softly on the layered terrain near the south polar cap a few weeks after the seasonal carbon dioxide frosts have disappeared. After the heat shield is jettisoned, a camera will take a series of pictures of the landing site as the spacecraft descends.

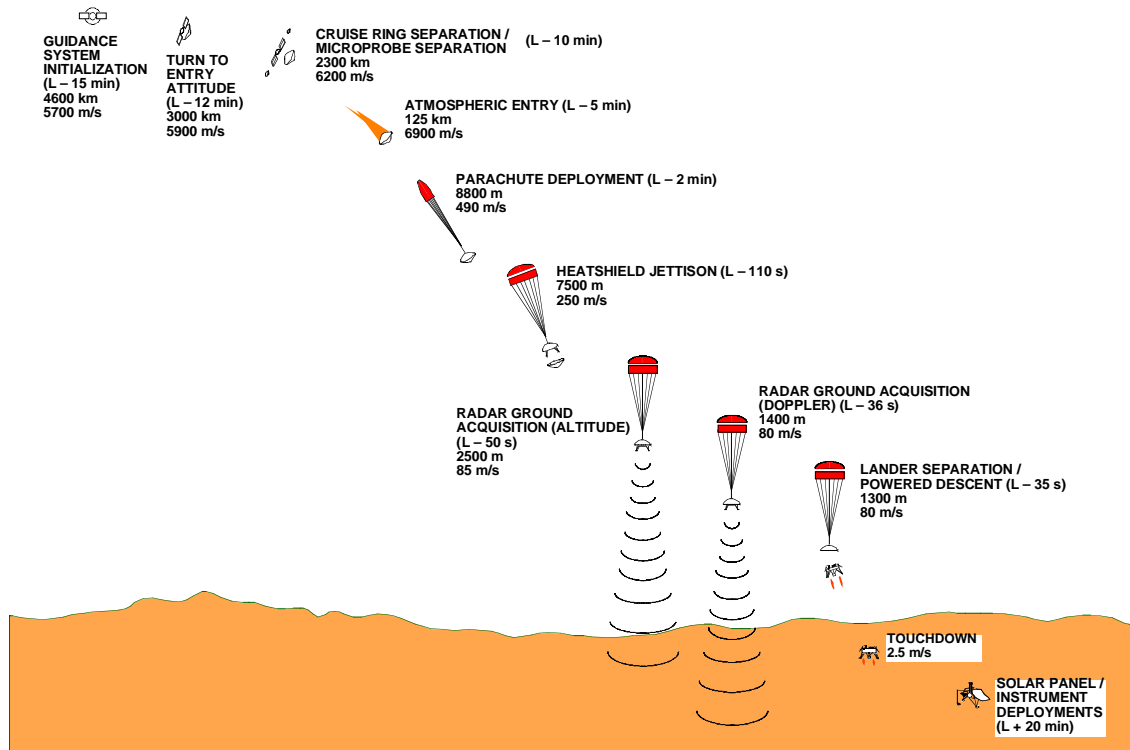
Figure 3

Entry/Descent/Landing Phase

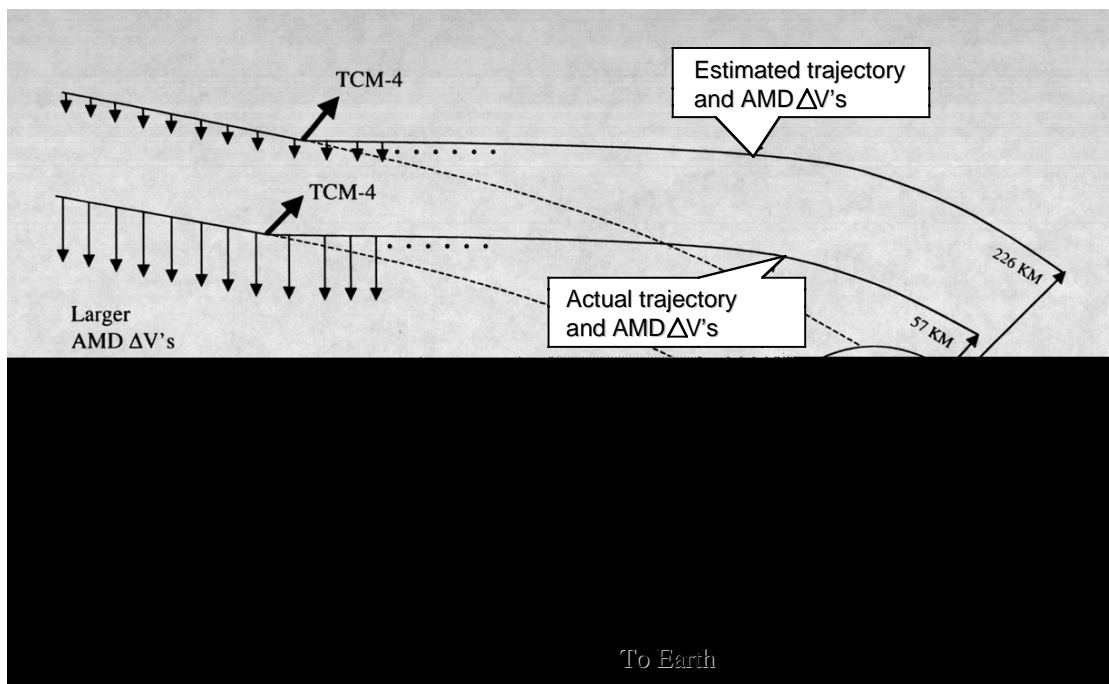
Figure 4

Schematic MCO Encounter Diagram

Not to scale

On September 8, 1999, the final planned interplanetary Trajectory Correction Maneuver-4 (TCM-4) was computed. This maneuver was expected to adjust the trajectory such that soon after the Mars orbital insertion (MOI) burn, the first periapse altitude (point of closest approach to the planet) would be at a distance of 226km. See figure 4. This would have also resulted in the second periapse altitude becoming 210km, which was desired for the subsequent MCO aerobraking phase. TCM-4 was executed as planned on September 15, 1999.
